### 5.3 Sts. John Creek

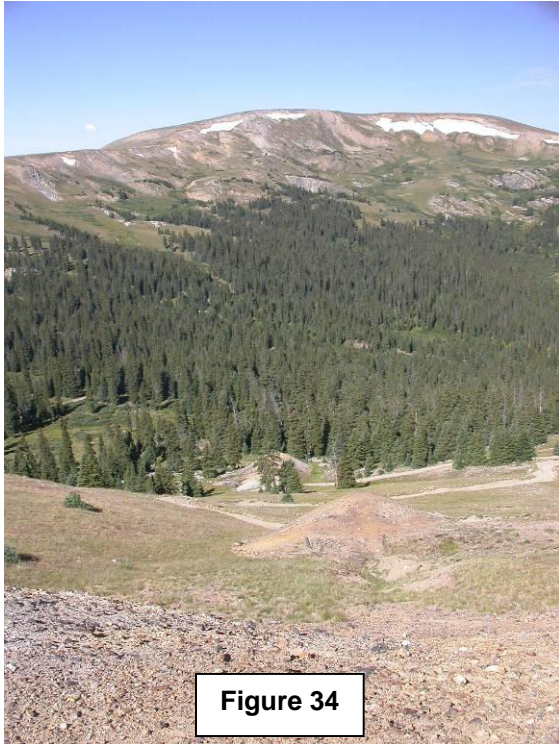
There are a number of old mines with significant waste rock in the upper eastern reaches of Sts. John Creek. The adits are all dry and the waste rock erosion small. Lower, the Wild Irishman mine has a draining adit and significant waste rock. The flow from the adit is along the north side of the waste rock. Figure 34 shows the lower half of the upper waste piles and Figure 35 shows the Wild Irishman Mine adit flow. In figure 34 the Wild Irishman Mine is the lowest waste pile shown. Figure 36 shows the flow of the adit on the north side of the waste rock pile.

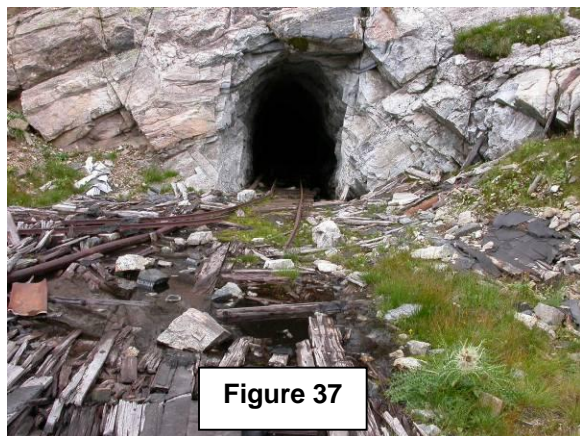
**Figure 37**

owned and a cabin of sorts has been built below the mine area. This mine is actually just north of the Wild Irishman Mine in a sub-drainage that starts only a few hundred yards north of the Wild Irishman Mine. Figure 37 shows this draining adit. There is considerable waste rock in the area. Flow is across the waste rock and then down to an eastern tributary.

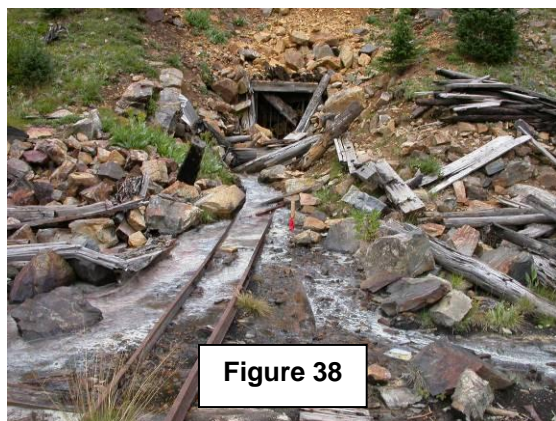
**Figure 38**

Only a few hundred yards from where an eastern tributary discussed above flows into Sts. John Creek is the Sts. John Mine and Mill site. This is one of the major problems in the Snake River Basin. The mine has a significantly draining adit, which is flowing across waste rock and tailings on its way to the stream. Further, water is seeping from the stream into areas disturbed by milling and the tailings from the mill contaminate the stream for hundreds of yards below the mine area. Major cleanup of the site is needed. Waste rock needs to be consolidated. The waters

Figure 38 shows the Sts. John Mine adit. Flow splits, with the majority going north and the rest heading across waste rock to the south. Figure 39 shows the north flow and Figure 40 shows the south flow. Figure 41 shows the north flow near its confluence with Sts. John Creek in August, 2007.

leaking from the stream need to be captured and channeled back into the stream before heading into a tailings area. The adit flow needs treatment. The tailings in the area of the mine need to be removed or consolidated and covered.

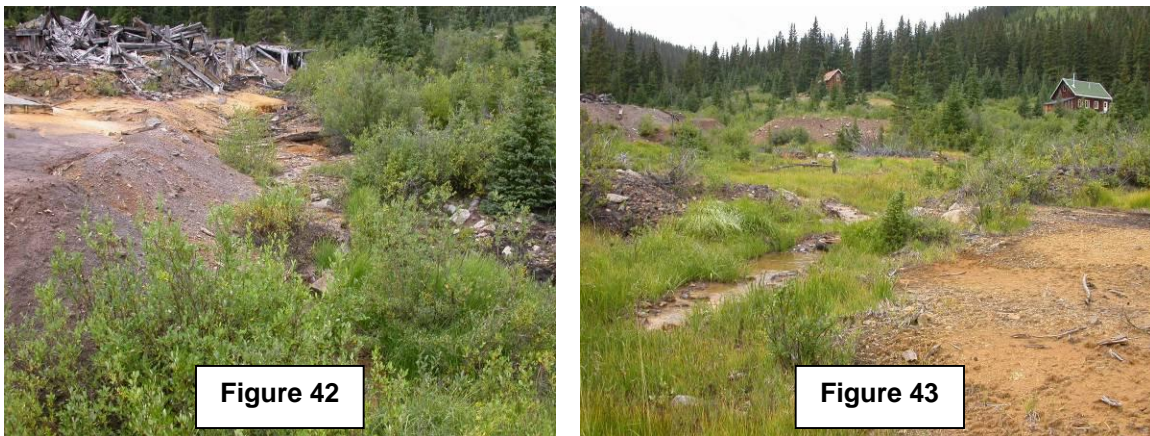
Figure 42 shows the seepage from the stream. This seepage goes on into an area of considerable tailings and eroded waste rock. This is shown in Figure 43.

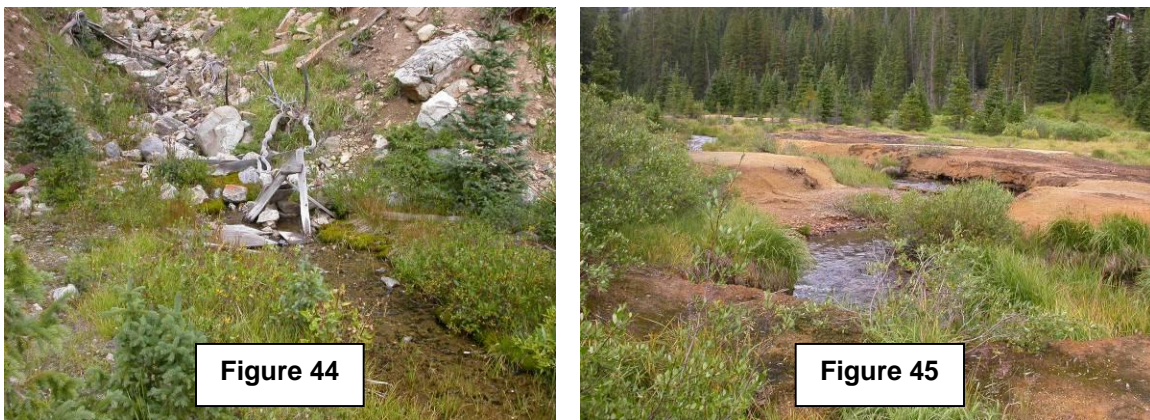
Not far below the Sts. John Mine, the creek enters a wide meadow. On the west side of the meadow is the Marlin Mine, with a draining adit and eroding waste rock. In the meadow, the creek meanders through significant tailings. Figure 44 shows the Marlin Mine and figure 45 shows some of the tailings in the meadow.
