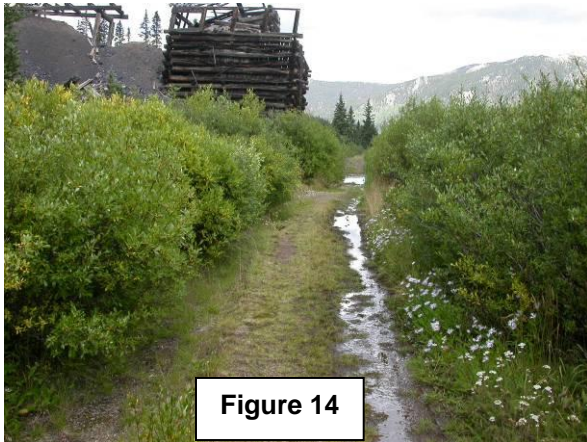
Figure 14

This mine north of the Burke-Martin Mine is shown in figure 14. The drainage shown is not from the mine, but from a seep in the mine area.

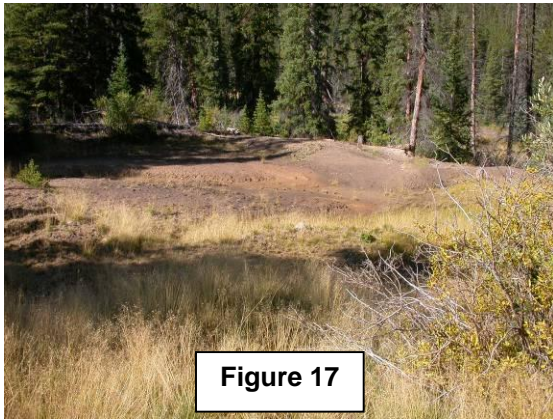
Figure 17 shows the lower end of this contaminated wetlands area. Figure 18 is flow from the contaminated area. This area is actively contaminating the Snake River.

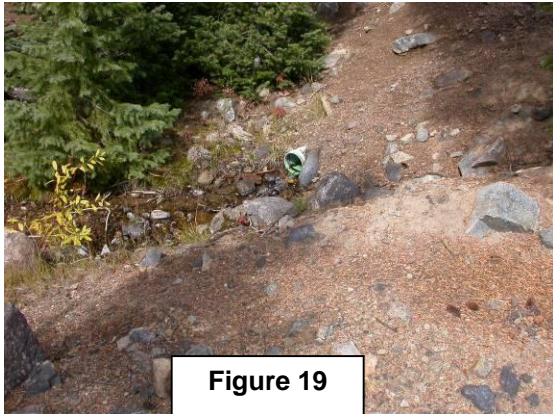
On the eastern side of the Snake River, in Montezuma and high on the hills above Montezuma are several other problem areas. At the south end of Montezuma is the New York Mine. This has been closed and waste rock scattered over a fairly large flat area. The adit is draining and a pipe was set up to get the flow off of the waste rock. The adit flow goes down the side of an access road to the main Montezuma road, then down the ditch to a culvert and to the Snake River. Figure 19 shows this draining adit and Figure 20 shows the flow down the access road to the main road.

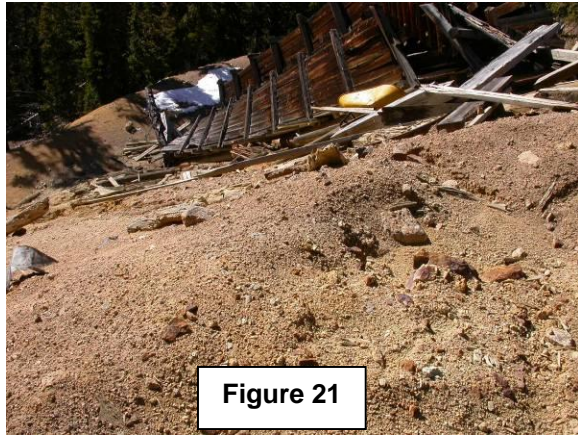
To the east of Montezuma are a number of mines. Some have draining adits and some are dry. In general, the higher mines are dry. However, the series of waste rock piles around the Quail Mine are all in a drainage and erosion is inevitable. Lower, in the general area of the Morgan Mine are several dry adits with significant waste rock. The Morgan Mine has been closed, but is draining and there is a large waste rock area that is eroding significantly. There is room for a passive treatment system for the adit flow and reclamation of the waste rock may be possible with an organic/zeolites mixture.

Figure 21 shows one of the upper mines waste rock. Figure 22 shows the adit flow from the mine north of the Morgan Mine. Figures 23 and 24 show the closed Morgan Mine and the waste rock pile associated with it.

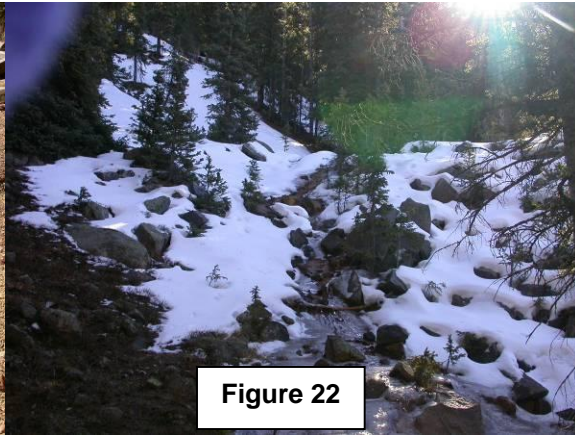
Figure 22

Below the Morgan Mine, to the north, is another mine with a significantly draining adit. This mine has significant disturbance around it. There is room for a passive treatment system of the adit flow and to consolidate waste rock. There are seeps in the area and field measurements suggested their water quality to be low. This is an area where water quality improvements are possible.
