5.4.3 Warden Gulch

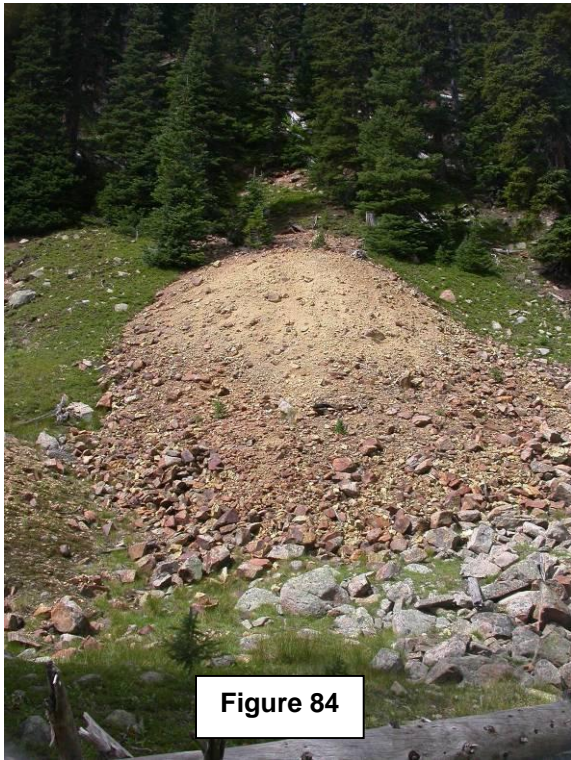
At the headwaters of Warden Gulch is the Allen Emory Mine. This mine is on the steep slopes at the end of the cirque. There does not appear to be a draining adit. However, there is considerable waste rock that is eroding. Dealing with this waste rock at the existing slope angle will be very difficult. North of the main drainage origination, and lower in the basin, west of the main flow there are several waste rock piles. All appear to be dry and all are, to some extent, eroding. One the south side of headwaters area there is another mine, high on the steep slope with considerable waste rock. This mine is in an area of unconsolidated rock on the surface and expected high mineralization. Doing anything to this waste rock would be very difficult and would most likely gain little. Figure 83 shows the Allen Emory Mine. Figure 84 shows a typical example of the waste rock piles on the northwest side of the drainage. Figure 85 shows the mine on the high south slope.

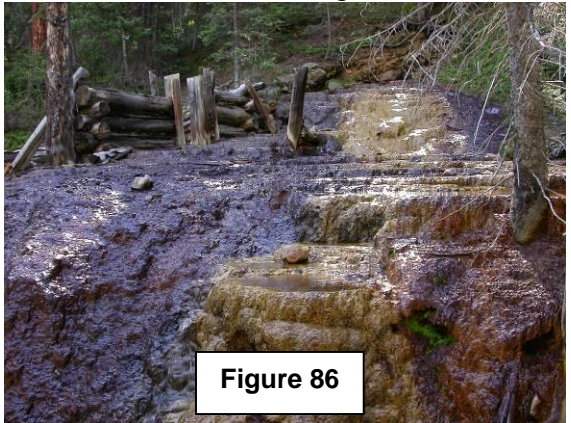
Figure 86

A few hundred yards above the confluence, where the road to the Allen Emory Mine approaches the stream is an old mine. The mine adit is draining and the water from the adit has created ferricrete deposits on the banks of the stream. There is room to the north to treat the adit flow with a passive sulfate reducing bioreactor. The waste rock and ferricrete need to be removed to a repository, although there might be enough room to consolidate them onsite and cover them. Figures 86 and 87 show two views of this mine.
