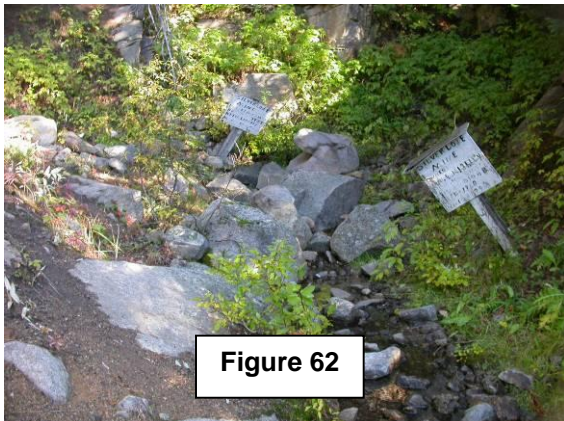
On downstream, there continues to be old mines on the north slope. Figure 62 shows one of these, the Silverlode Mine. Figure 63 shows another one, just west of the Maid of Orleans Mine. The Maid of Orleans Mine has been listed as having a draining adit in past studies (Munroe, 1999). The owners have allegedly closed the adit. A small spring remains. This is an area of private property.
