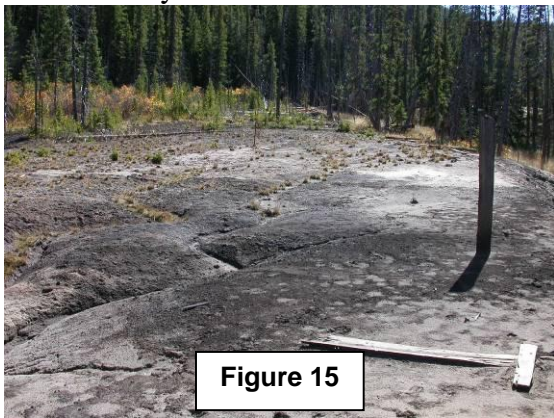
Not far below the confluence of Sts. John Creek, in the town of Montezuma, there was once a mill. Tailings from this mill affect a large area just below town. This area has considerable private property and some of the tailings have been moved around for house and road construction. Other large pockets of tailings remain. The tailings are in a wetlands area, making their impact worse. Further, on the east side of the stream, just below town is another old mine with a leaking adit. As with the Burke-Martin Mine, this adit flow has been captured and is routed directly onto waste rock, which it flow down on its way to the Snake. Further, the wetlands area below the old mine/draining adit have been contaminated with tailings and waste rock. Some of this has eroded closer and closer to the stream and some remains in dams and piles. Figure 15 shows some of these tailings and figure 16 shows the draining adit. The flow is difficult to see from this distance, but is easily visible to anyone on the road.
